JMH Building Inspections Pty Ltd

Visual Timber Pest Inspection Report

VISUAL TIMBER PEST INSPECTION REPORT as per AS4349.3-2010

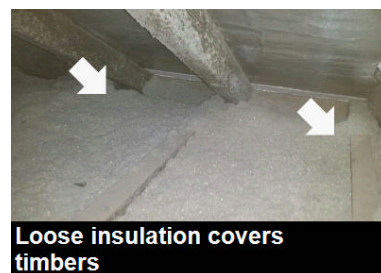
Inspection over the eaves was restricted due to the low pitch and construction allowing only a limited visual inspection from a distance to be carried out. Loose insulation is also present in the roof cavity. This restricted inspection to some roofing timbers. As a general rule, loose insulation restricts inspection to more timbers than conventional insulation batts. Removal of insulation is not within the scope of a standard visual timber pest inspection report however, this would be necessary for a more complete report to be submitted.

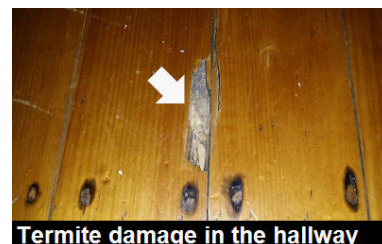
Yes - Inspection revealed currently inactive termite attack (damaged timbers and/or termite workings) within this area including but not necessarily limited to the following timbers and the areas listed below. Also refer to section 5.0 (Evidence of Termite Damage) at the end of this report.

Termite damage in the hallway

Visible timber damage appears minor to moderate.

Unless written evidence of a termite protection program in accord with Australian Standards 3660 is provided, a termite management program is strongly recommended to reduce the risk of further attack. In any event, damage may be present in concealed areas and a further INVASIVE INSPECTION is strongly recommended, see Section 3.0 - Further Invasive Inspection.

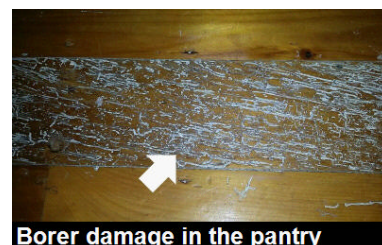
Borer damage in the pantry

Anobium borer damage was noted to most flooring timbers. See summary regarding treatment options.

Visible timber damage appears minor to moderate.

Anobium punctatum borer damage is evident to softwood flooring. It is not possible to determine whether activity exists without destruction of the timbers. We recommend that it would be prudent to assume that current borer activity is present unless written evidence is available to indicate that the property has been recently treated in respect to this borer. Replacement of affected timbers is always preferred as a long term solution however, a chemical treatment to control re infestation may be considered a less effective and lower cost option. This treatment is applied to the underside of all soft pine flooring timbers.

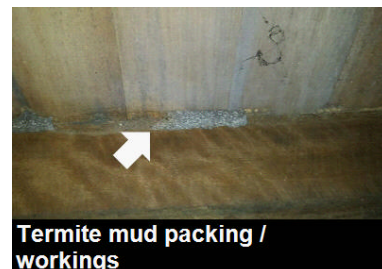
Affected subfloor timbers

Yes - Inspection revealed currently inactive termite attack (damaged timbers and/or termite workings) within this area including but not necessarily limited to the following timbers and the areas listed below. Also refer to section 5.0 (Evidence of Termite Damage) at the end of this report.

Framing and flooring timbers below the hallway and bedroom three.

Visible timber damage appears minor to moderate.

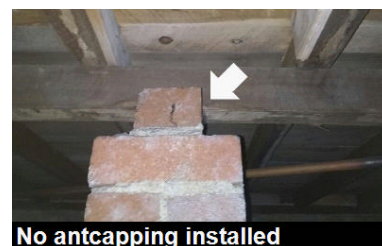
We also note the general lack of ant capping. The purpose of ant capping is to reduce the risk of concealed termite attack by ensuring that termite workings are exposed and visible. Ant capping should be repaired or installed where possible. If this is not possible, regular inspections are recommended. Missing, damaged or poor termite ant capping increase the risk of termite infestation.
